SONIC INVESTIGATION OF MASONRY STRUCTURES

THESIS SUBMITTED TO THE UNIVERSITY OF EDINBURGH

FOR THE DEGREE OF DOCTOR OF PHILOSOPHY

DEPARTMENT OF CIVIL ENGINEERING AND BUILDING SCIENCE

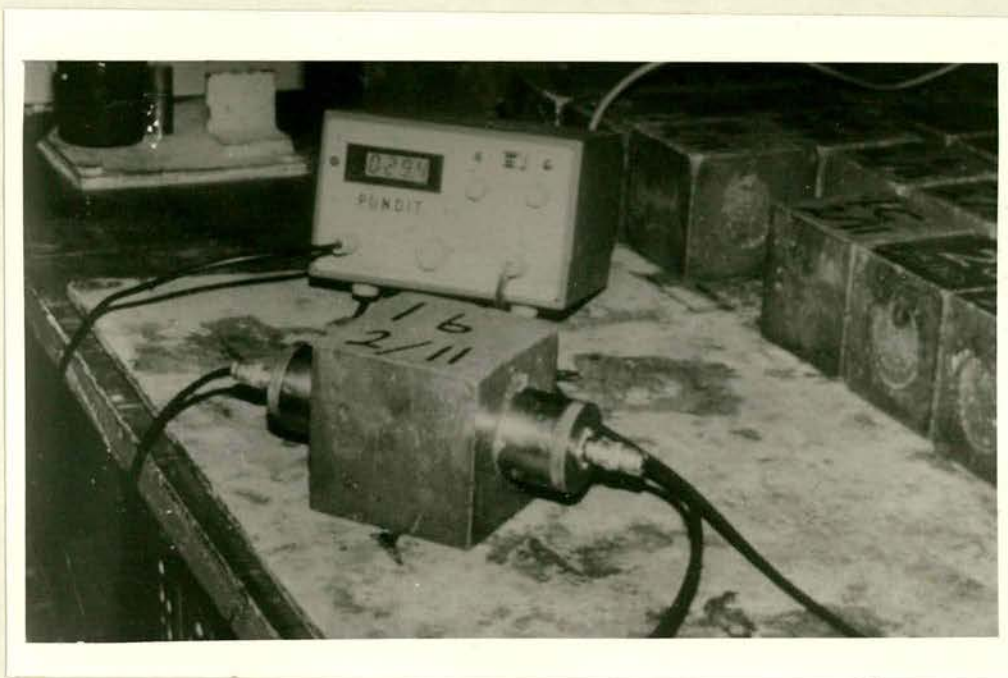
Plate 4.1 Mortar cube testing, pulse velocity measurement

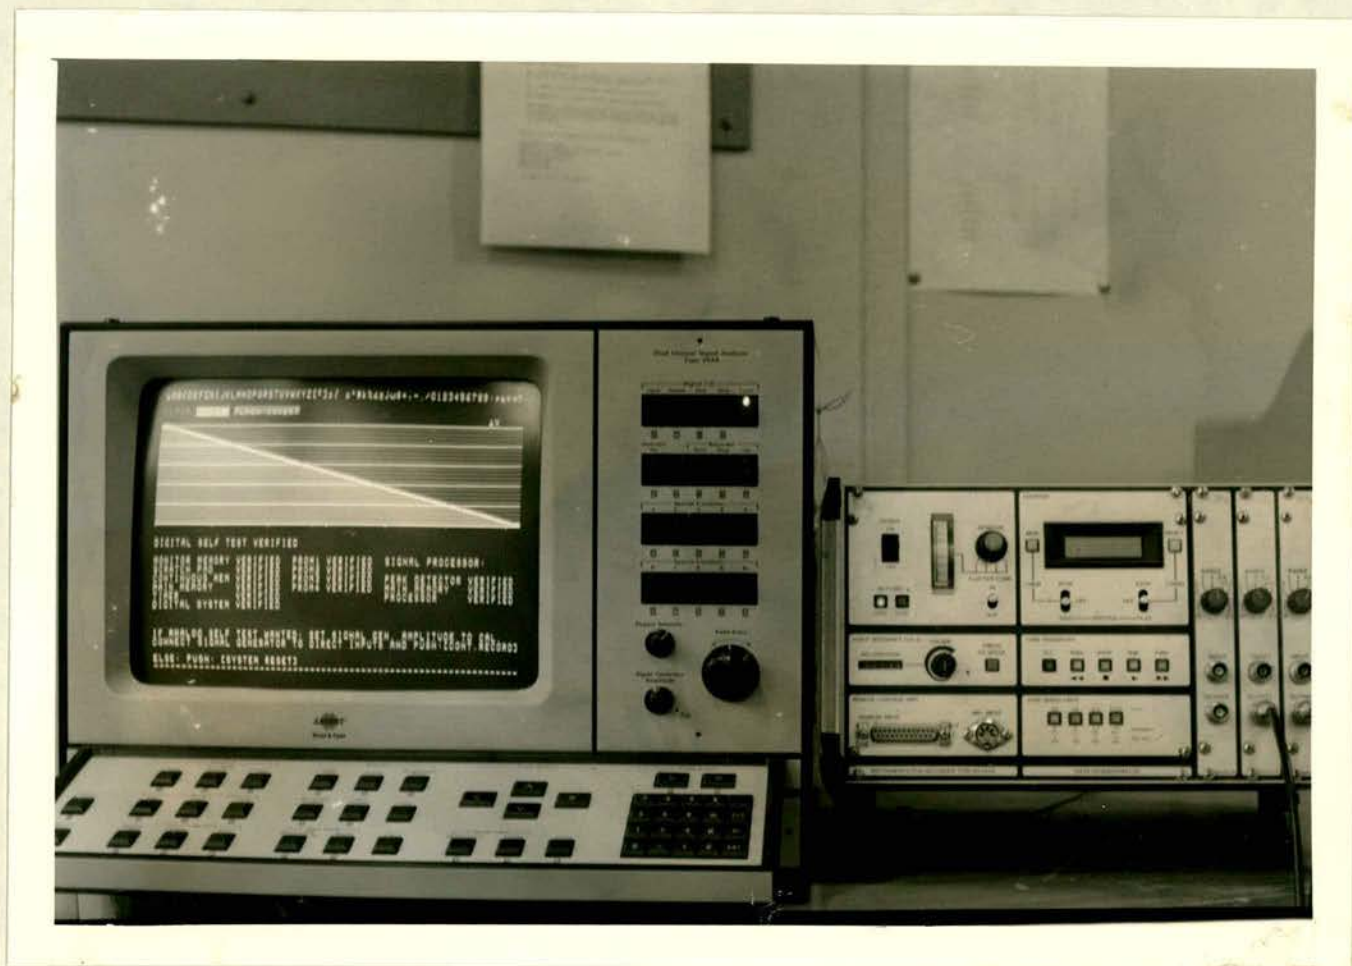
Plate 7.3 Bruel & Kjaer 2034 and FM high frequency tape recorder
